PONT-ATEB Sub Group

Summary Report on the visit to Mbale, November 2011

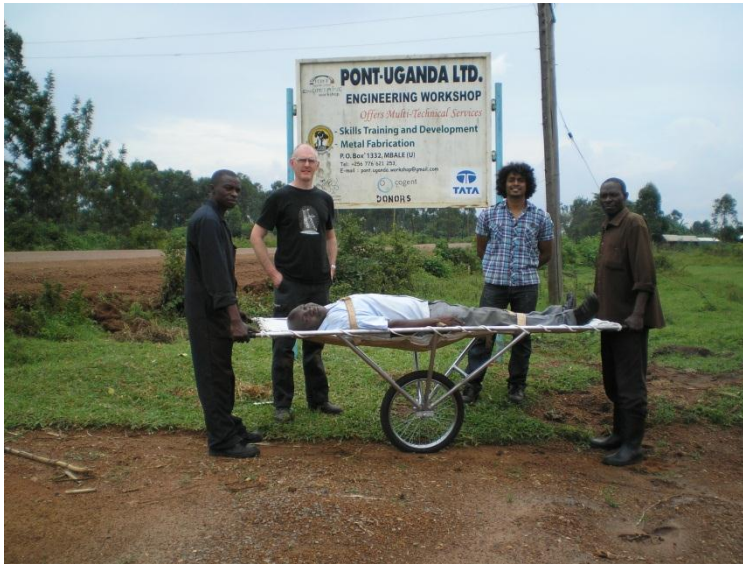
The student came on the visit, and supervised and advised the workshop staff in the production of the prototype. The prototype was successfully built, and the paramedics on the visiting team assessed it, and were satisfied with the design.
